Keel bolt integrity failure: the hidden killer

The May 2014 capsizing of the yacht *Cheeki Rafiki*, a tragedy which led to four fatalities, could well be linked to keel bolt integrity failure, argues Capt Ed Geary

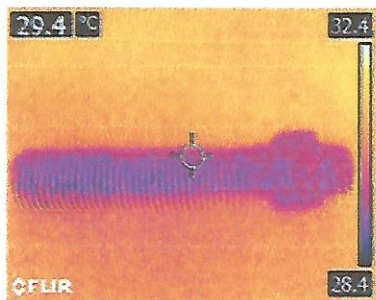
Pictures A+B: while still in place, the upper shaft and nut of the keel bolt displayed major corrosion (above). Following its removal, the extensive corrosion was further confirmed by thermal imagery (right)

such as a container. When a fin keel strikes a semi-submerged obstacle, the hull will sustain damage either forward, aft or both forward and aft of the keel-to-hull join. With no impact or laminate damage to the hull forward or aft of where the keel was attached, there is no basis to support the theory of striking a submerged object. The blade rudder was also undamaged. The undamaged apertures of the forward and aft keel bolts, and their clean separation, indicates the keel bolts and securing nuts failed as a result of microstructural degradation/metallurgical deterioration, resulting in the loss of the keel (see pictures A and B).

The loss of keel bolt integrity can occur due to crevice corrosion of the lower shaft, or as a result of corrosion of the upper shaft and the nut whose sole purpose is to tightly secure the keel against the hull. For this reason, when conducting MCA code of compliance inspections or even a basic condition and valuation survey, surveyors must always insist that the correct torque of the keel bolts be confirmed in accordance with the manufacturer's specifications, which is easily verified using a calibrated torque wrench.

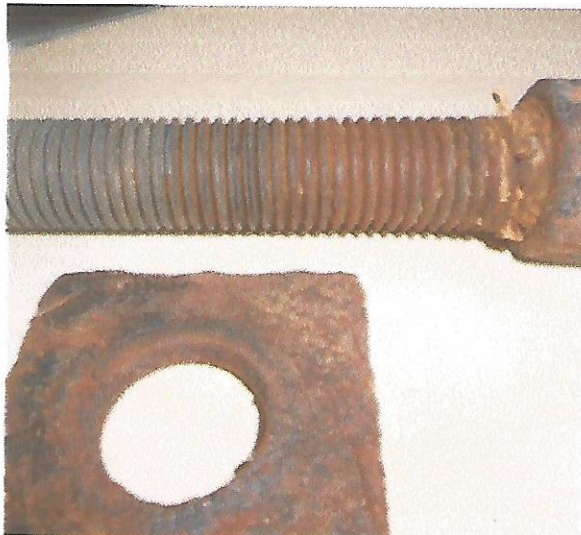
The rusted backing plates, while structurally sound, displayed surface corrosion but would not have had any restraining effect when the corroded keel bolt nuts failed, releasing the keel
